Short Communication:

Causes of the triggering of Chamoli glacier burst of 7th February 2021 in Uttarakhand, India

University School of Environment Management, Guru Gobind Singh Indraprastha University, New Delhi-110078, INDIA

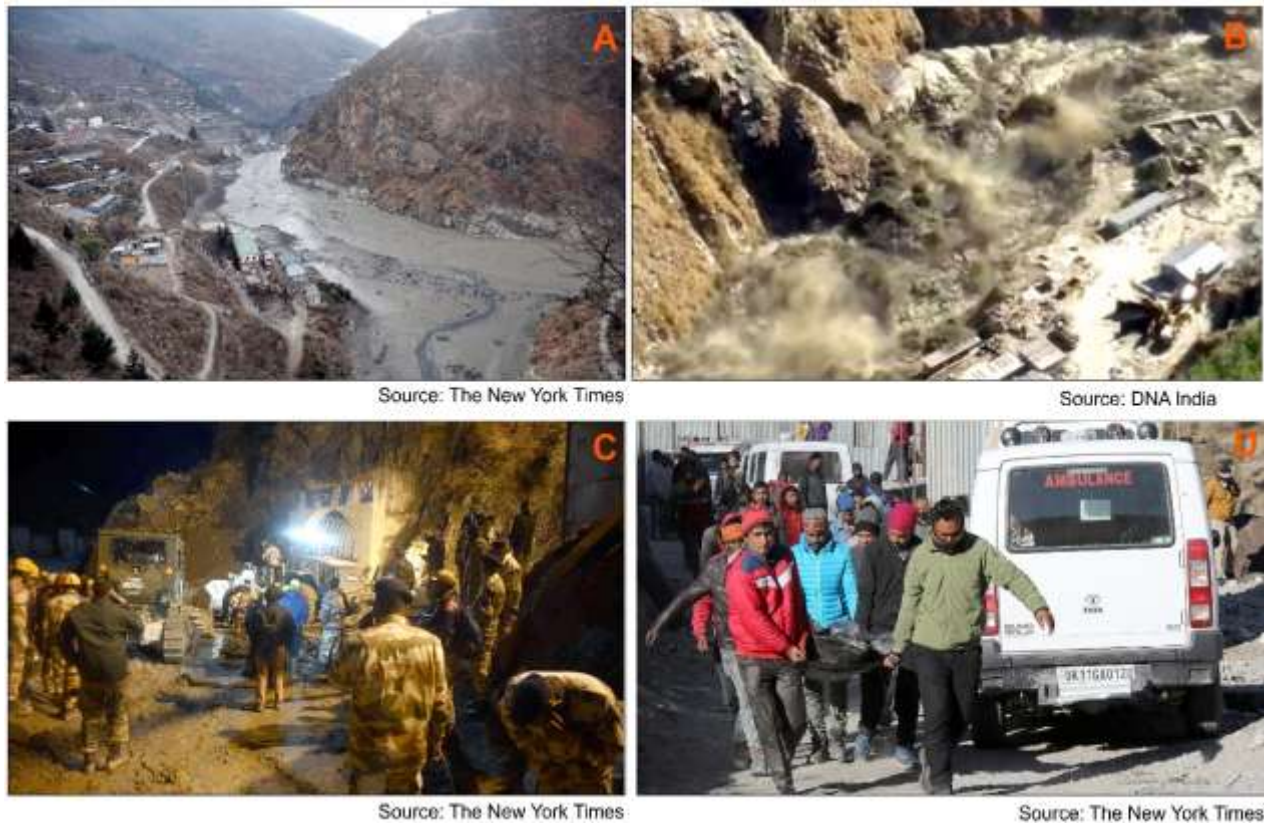
Figure 4: Field photographs (A) Tapovan project after the disaster¹⁹ (B) Dust plumes in the Dhauli Ganga river³ (C) Rescue operation for the people stuck in the tunnel¹⁹ and (D) Rescue operation of the injured people by the local authority¹⁹

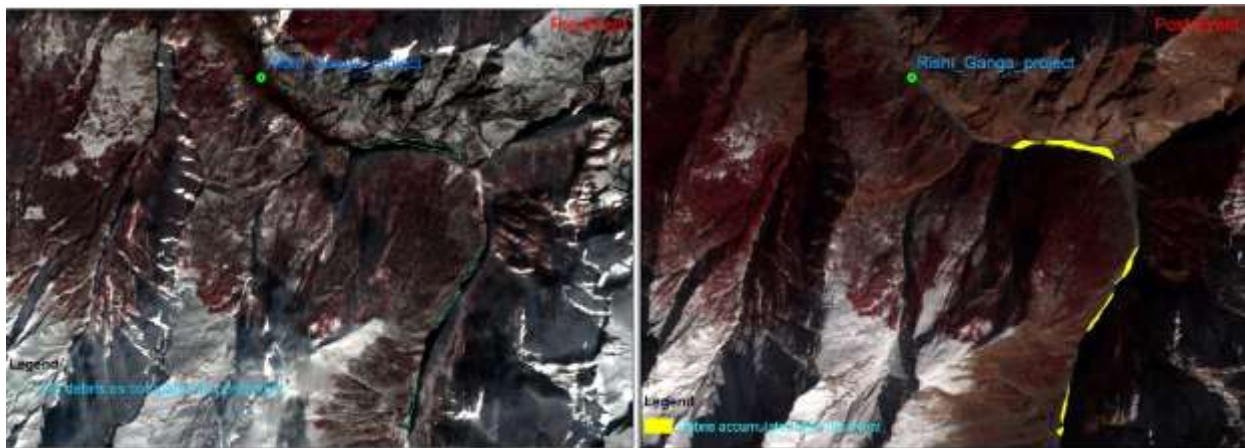
In the pre-event (5th Feb. 2021) and post-event (10th Feb. 2021) satellite imagery of Sentinel 2, it is clearly visible that the snow cover has reduced to a larger extent (Figure 5), which also supports the weather forecast model of ISRO. Also, in the post event image, a lot of debris can be seen accumulated in the river bank.

Figure 5: Pre (5th February, 2021) and Post (10th February, 2021) satellite image where the difference in snow cover and debris accumulation after the event is obvious

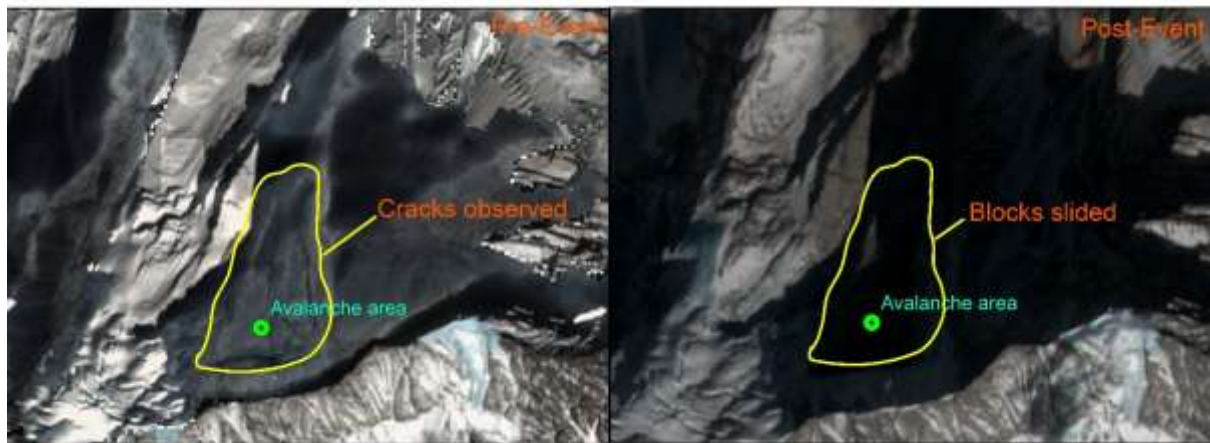
From the pre- and post-event satellite images of the affected area, a huge rock slide has taken place near the glacier. The huge cracks in the rock are observed in the pre-event satellite image, wherein the post-event data the block has already slides leaving behind a hollow structure (Figure 6). The ice melted quickly due to the landslide moving northwards along the Rishi Ganga valley, causing a massive surge of water which turned westward into the Dhauli Ganga valley.

Cracks and fractures in Trishul glacier: The trapezoidal stretch of cracks (Figure 6) was observed before the

initiation of the disaster. The vicinity of the spot where these cracks have developed and due to the freezing and thawing effect of glacier, the rapid slide of glacier volume occurred. Furthermore, the melted glacier's sudden movement along the downslope increased the spontaneous volume of water in Rishi Ganga River.

Figure 6: Pre (5th February, 2021) and Post image (10th February, 2021) where the cracks in the pre and the post avalanche in the Sentinel 2 image are obvious

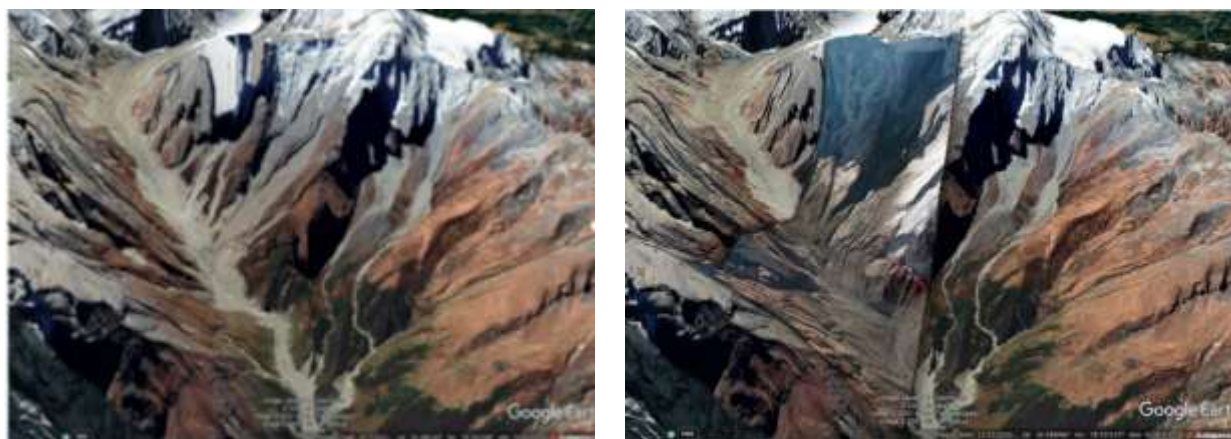
Figure 8: Change in hill slope observed in two different time period¹⁶ (7th July, 2017 and 22nd November, 2020)

While comparing hill slope from the satellite imagery of two different time period (7th July, 2017 and 22nd November, 2020) of pre disaster event, in the later picture, the large block that has failed is obviously seen, as it is the very steep slope down which the debris travelled. Before moving down the gorge, the debris seems to have travelled some distance up the opposite slope (Figure 8). The dust deposition region in the upper part of the direction of the flow is obvious. The flow appeared to have been gradually limited to the lower part of the valley, perhaps as it developed into a flow of rubble.¹⁶
