Review Paper:

Forensic Analysis of a Distressed Railroad Embankment

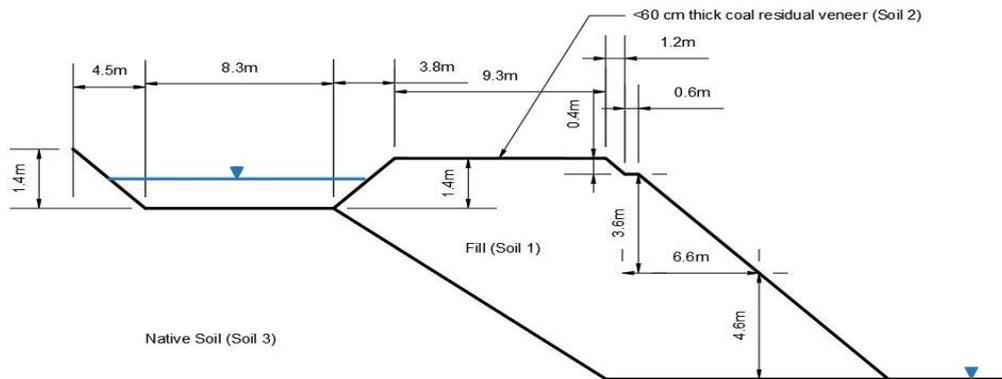
Figure 1: Embankment model

The embankment is having 9.3 m top width and height 8.2 m made up of silty sand resting on silty clay (native soil). The water has accumulated on the left of the embankment up to a depth of 1.4 m due to heavy rainfall as shown in fig. 1.

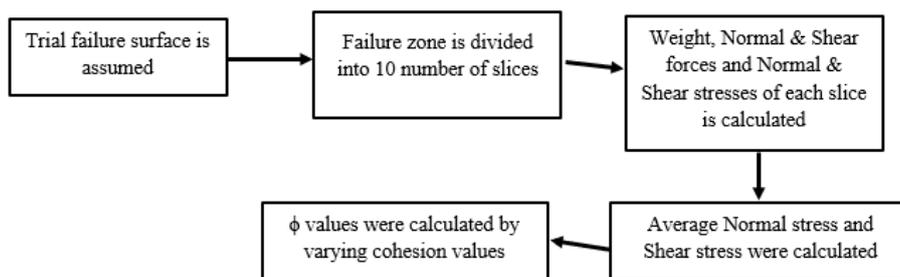
Figure 2: Stepwise process to find Ø value

Resistance envelope approach: Critical failure surfaces can be retrieved by evaluating the embankment in various software. Investigating the slope of an embankment in an analytical approach is the latest or evolving methodology. In this research, the task is to find out the potential failure surface using an analytical concept called resistance envelope approach as shown in fig. 2.

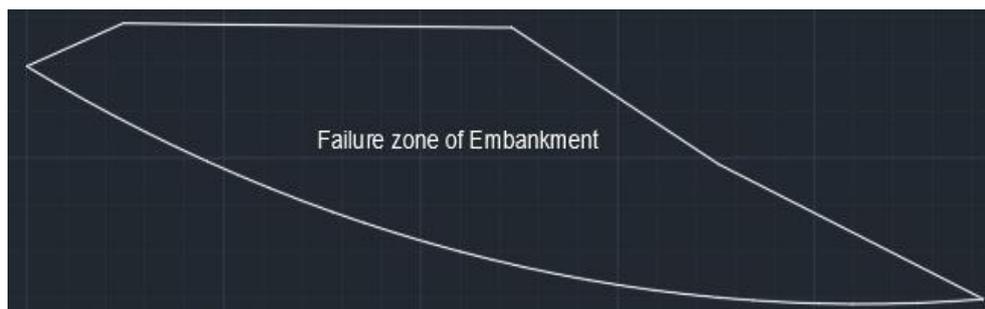
Figure 3: Assumed failure region of an embankment

STEP 1: The cross-section of embankment is drawn in Auto-cad 2019 and weak surface is picked which is originating from the left of an embankment and terminating near the foot of the embankment as shown in fig. 3.

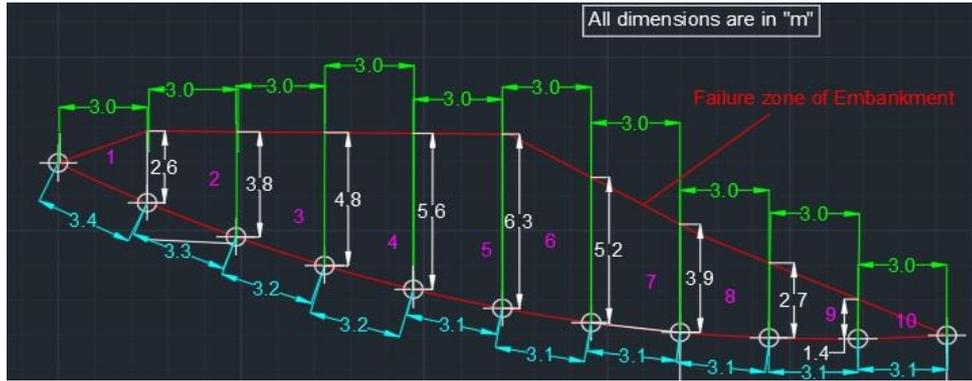
Figure 4: Failure zone divided into 10 number of slices in Auto-cad 2019

STEP 2: The failure region is divided into 10 counts of slices and then all the measurements of slices are noted as shown in fig. 4.

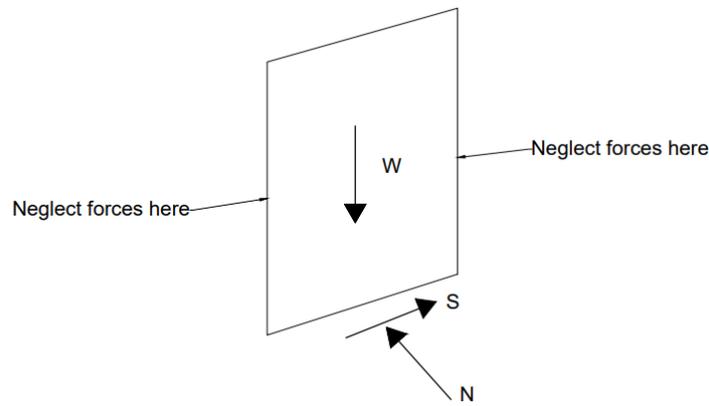
Figure 5: Slice with forces

STEP 3 - Ordinary method of slices: In this method, the forces on the sides of the slice are neglected as shown in fig. 5.

Area of slice (A) = Height of slice * Width of slice
 Volume of slice (V) = Area of slice * 1 m length of slice
 Weight of slice (W) = Volume of slice * Unit weight of slice
 Normal Force (N) = W cos α
 Shear Force (S) = W sin α
 α = Angle between the horizontal and base of a slice (Degrees)
 Normal Stress (σ) = $\frac{\text{Normal Force}}{\text{Base Area}}$
 Shear Stress (τ) = $\frac{\text{Shear Force}}{\text{Base Area}}$

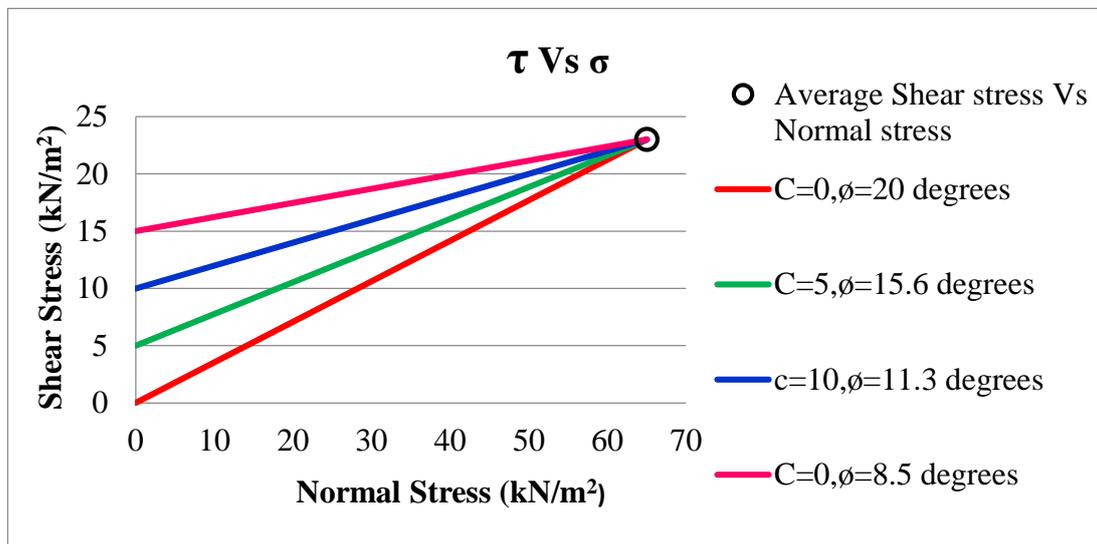
Figure 6: Graphical representation of (ϕ) angle of shearing resistance value obtained by varying (c) the cohesion

STEP 4: Initially, shear stress against the normal stress component is plotted. Shear stress intercept (Cohesion intercept) is managed to keep at zero and a line is crossed drawn from zero and finishing at (τ Vs σ) coordinate. Similarly, the shear stress intercept differed by five variables and lines are created to cross the (τ Vs σ) coordinate. The

slopes of all the lines are evaluated and that implies the angle of shearing resistance (ϕ) as shown in fig. 6. The angle of shearing resistance is estimated by differing cohesion intercepts starting from zero as shown in table 2.

It is asserted that perhaps the failure surface selected is not really the actual critical failure surface as the value of the angle of internal friction acquired is 20° at nil cohesion. However, the exact value of the angle of internal friction at the loosest state is $\phi=45^\circ$. To really get the exact failure surface, various textures are chosen and the same process is managed to carry out.

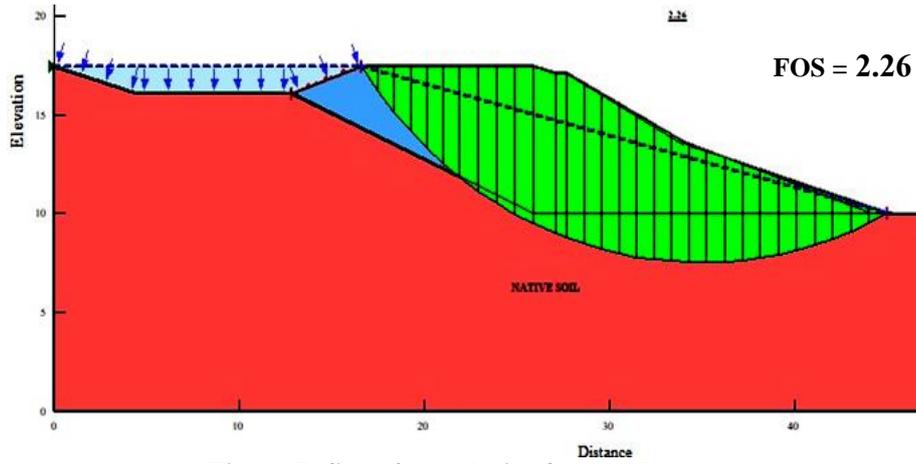
Figure 7: Slope/w analysis of embankment

Slope/W analysis: Slope stability analysis is conducted using the Geostudio 2012 program in which the embankment is having 2 distinct layers of different cohesion, shearing friction inclination and unit weight measurements as shown in table 3. For such a research scenario, the stability analysis is carried out using Geostudio 2012 software. The approach used for slope stability analysis is Morgenstern-Price approach to determine the factor of safety and Mohr-coulomb material model is used to model the soil materials using Geostudio (2012). The factor of safety obtained for critical failure surface is obtained as 2.26 as shown in fig. 7.

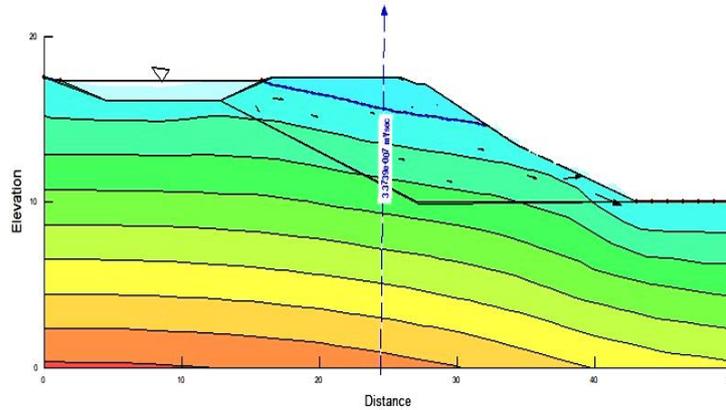
Figure 8: View of Pore water pressure

The seepage study has been carried out with the use of tools from Geostudio 2012. The results are estimated for the volume of flow that crosses the segment of the embankment. The volume of flow that crosses the embankment segment, is estimated as $3.859e-007 \text{ m}^3/\text{sec}$ as shown in fig. 7 and fig. 8. Flux section view is shown in fig. 9. Across the height of the embankment of 18 m, the pore water pressure profile is illustrated in fig. 10.

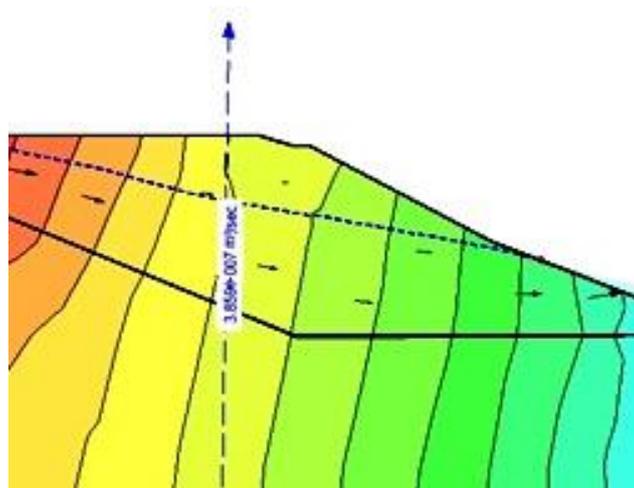
Figure 9: View of Flux section

SEEP/W analysis: Seepage analysis of embankment is undertaken using Geostudio software (2012) by using the required parameters as shown in table 4. The volume of flow going via the embankment cross section is identified by adding the segment flux.

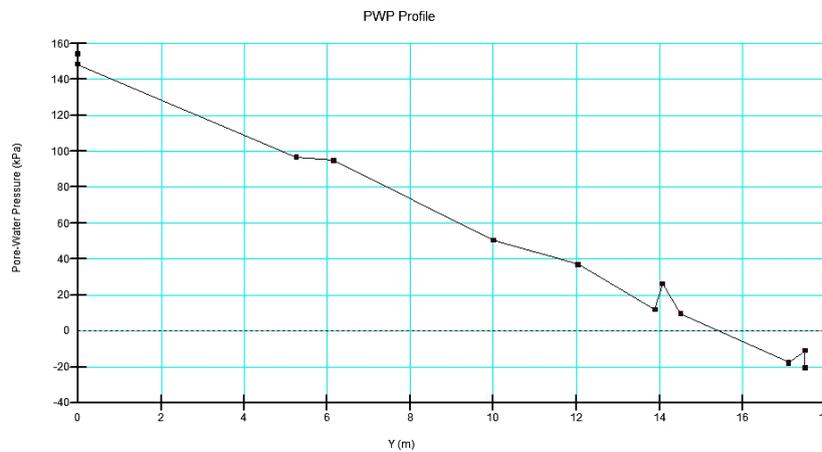
Figure 10: Pore water pressure profile

By varying the height of the embankment by 2 units, pore water pressure is drawn. The fluid pressure gradually decreases from 150 kPa to 99 kPa at 0 m to 5.5 m height and is stable at 0.7 m height and yet again decreases sequentially from 99 kPa to 15 kPa at 6.2 m to 13.9 m. This pressure rises again from 18 kPa to 30 kPa at 14 m height and then next it gradually decreases from 14 m to 18 m to 0 kPa. From the slope stability analysis of the embankment by using the Geostudio software, the potential failure layer starts from the upper left corner of the embankment, passes via the layer 1 (bank fill) to the layer 2 (native soil) and ends at the toe of the layer 1. The critical failure plane acquired utilizing the Geostudio software is picked up and the shear variables are discovered using an analytical method and both the failure planes are compared.

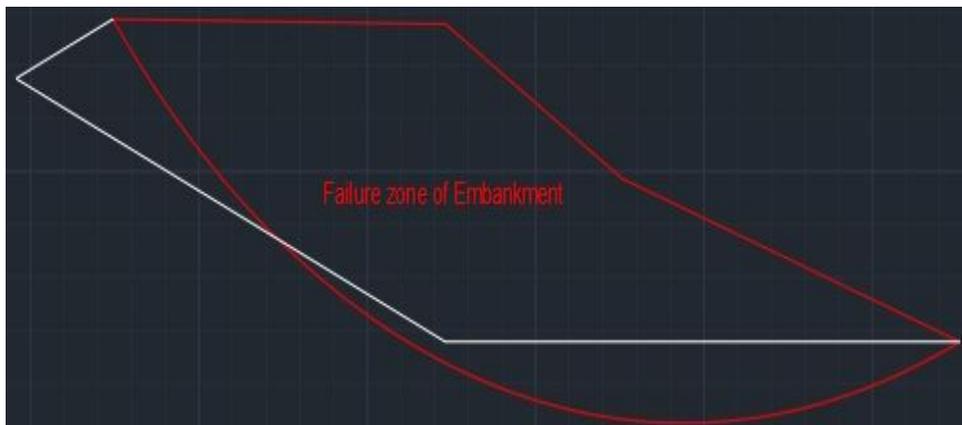
Figure 11: Failure zone of embankment obtained from AutoCAD

failure plane is validated analytically using the Resistance Envelope method. In this approach, the shear strength variables are evaluated and compared with the original parameters. The cross-section of the embankment is drawn in AutoCAD 2019 and the critical surface is taken from Geostudio which is originating from the left of the dike and terminating near the foot and is drawn as shown in fig. 11. Failure region is divided into 10 counts slices and then all the measurements of slices are noted as shown in fig. 12.
