Two Dimensional Unsteady Dam Breach Analysis using Fuse Plug Models

Abstract

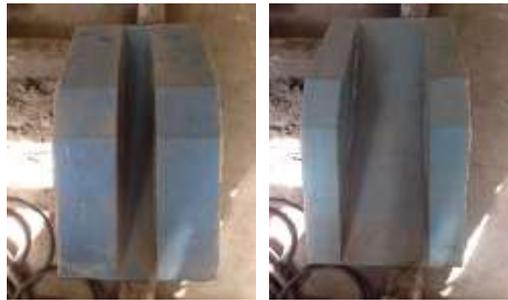
Fig. 2: Fuse plug models FP-1 and FP-2

The fuse plug models were made of wood and were painted before placing in the flume channel to avoid seepage during the tests as shown in figure 2. The flume had a square section of 0.57 m x 0.57 m and was 4.5 m long (Figure 3).

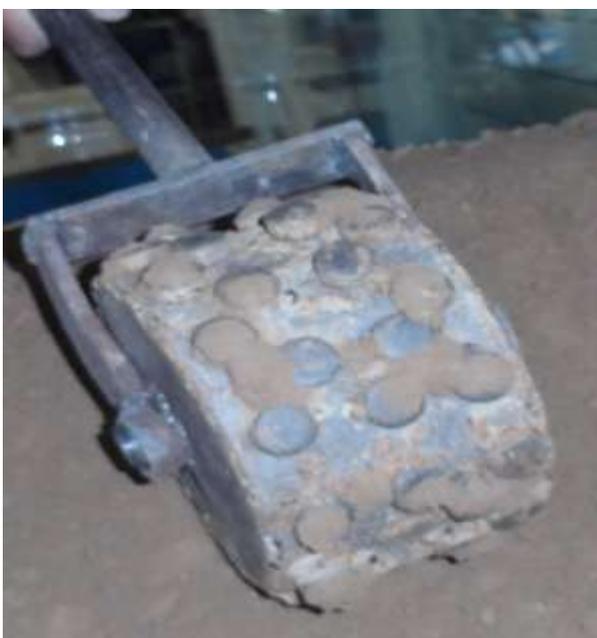
Fig. 4a: Hand operated roller

The embankment material was mixed at optimum moisture content corresponding to maximum dry density and was placed in layers of 8 cm each. These layers were compacted with a hand operated compaction roller (Figure 4a). To reduce seepage, a layer of pure clay was placed on upstream side of embankment. After construction, the model was left as such in this position for 24-48 hours.

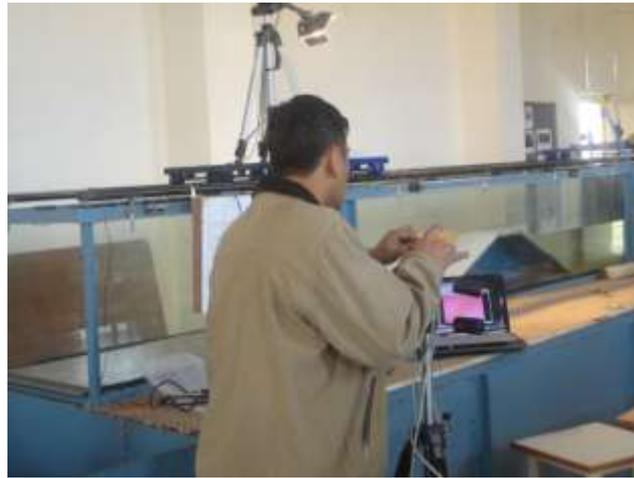
Fig. 5: Experimental Set up

The temporal variation of breach growth was observed with a high speed digital video camera (Fastec Imaging Inline Gigabyte Ethernet Camera) (Figure 5) along pointer gauges with rolling carriage.

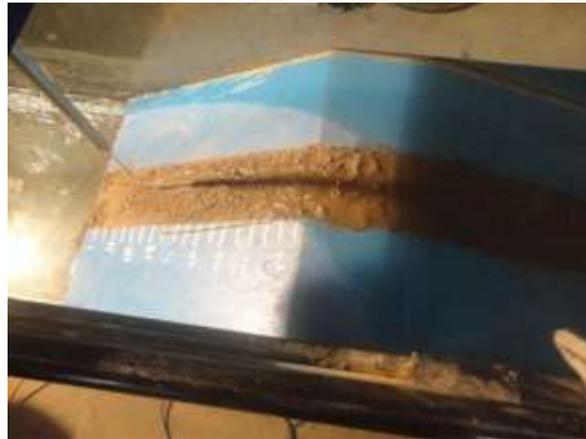
Fig. 7(a): Surface erosion on downstream side and over the crest

Phase of breach initiation: Both the categories of fuse plugs had same fill material in the analogous models. Accordingly, they exhibited similarities in the initiation of erosion. For models with predominantly non-cohesive material i.e. FP 1.1 to FP 1.4 and FP 2.1 to FP 2.4, the first signs of erosion were observed on the surface of the downstream face of the filling along the path of first stream of overtopping water (Figure 7a). The material on the surface was not able to resist the erosion and in a matter of about 10 sec the water had developed a narrow channel.

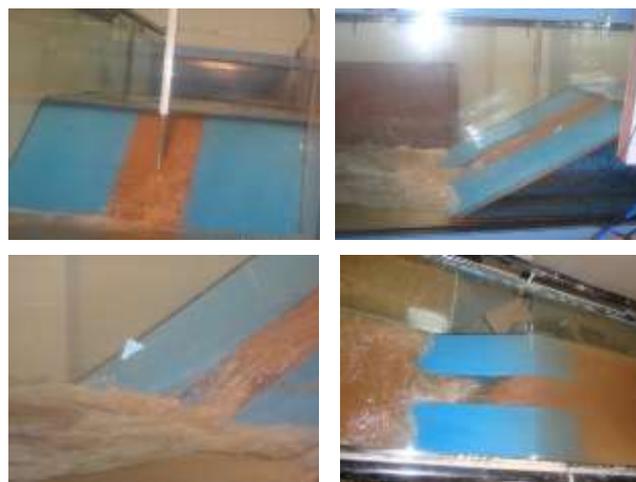
Fig 7(b): Erosion at downstream toe

However, in the case of model with cohesive material, i.e. FP 1.5 to FP 1.8 and FP 2.5 to FP 2.8, the overtopping water failed to make any distinct mark on the crest or the downstream face for a considerable duration. The first visible sign of erosion commenced at the downstream toe of the fill material (Figure 7b) and progressed upward. It was very clear that whereas for the non-cohesive material it started from top to bottom, it started from bottom towards up in the predominantly cohesive material. However, for the same fill material, there was no basic difference in the two categories of fuse plugs in the initiation of erosion and correlates with the observations of Walder et al²².

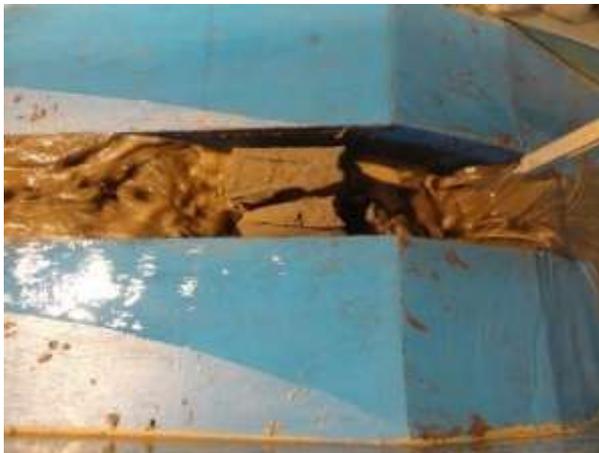
Fig. 8(a): Caveing in of sediment

These experiments are useful to understand the erosion mechanisms of breach under cohesive and non-cohesive fill material because of the confinement of the side walls, the process, at best presents a 2-D breach analogy as shown in figure 8a. The experiments conducted by Schmocker and Hager¹⁴ support these results. According to these authors, the morphodynamics of 2-D experiment, in which water spills over the entire embankment, was different as the water surface would be nearly parallel to the bed surface.

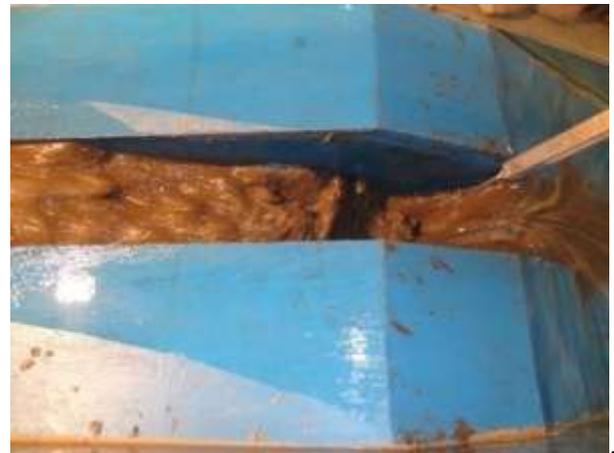
Fig. 8(b): Widening of breach

But in the case of non-cohesive material for the remaining models, a sudden and complete washout of the fill material occurred in a few seconds (Figure 8b). Under similar conditions, the total breach time was less and the breach widening was more in case of FP 2. It was due to the larger crest length of FP2 which in turn had increased the infiltration process and also the time to breach.
